RE: 2014-2015 Annual Report for United Heckathorn Superfund Site
Upland Capping System
Richmond, California

**2014-2015 ANNUAL REPORT
FOR
UNITED HECKATHORN SUPERFUND SITE
UPLAND CAPPING SYSTEM
RICHMOND, CALIFORNIA**

Levin Richmond Terminal Corporation
402 Wright Avenue
Richmond, California 94804

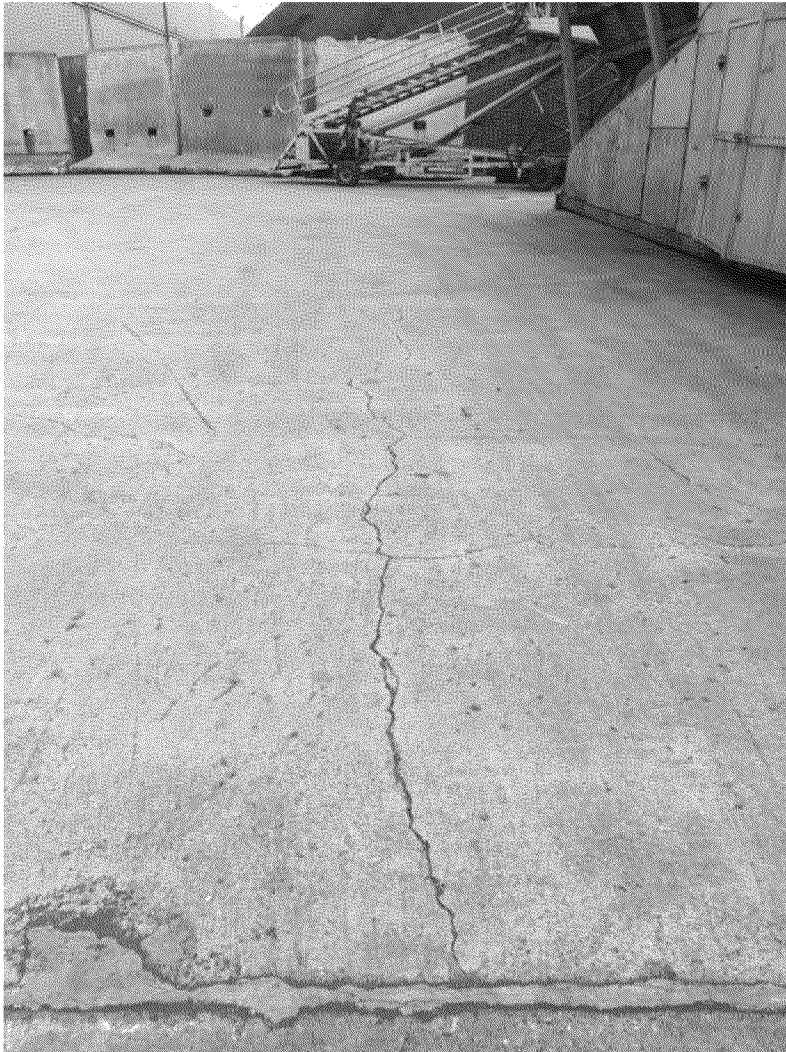
- **SW-3 Area** – Minor surficial cracks were observed within and to the west of the bulk product storage area, with heavier cracks and seams located to the northwest of interceptor SW-3 at the southern end of the upland capping system (Appendix A; Photos 1, 3, 4, and 5). Cracks and concrete seams identified as high priority in the previous inspections were observed to have been patched (Appendix A; Photo 2).

Photo 1 – Looking south along western alley of secondary storage area: surficial cracking in SW-3 area, with sealed crack in foreground.

No evidence of cracks, gaps, significant cap deterioration, or other material breach with apparent potential for exposure of the underlying subgrade was observed during the inspection. Weiss recommends that LRTC continue to monitor minor cracks noted during the inspection. No repairs are recommended at this time.

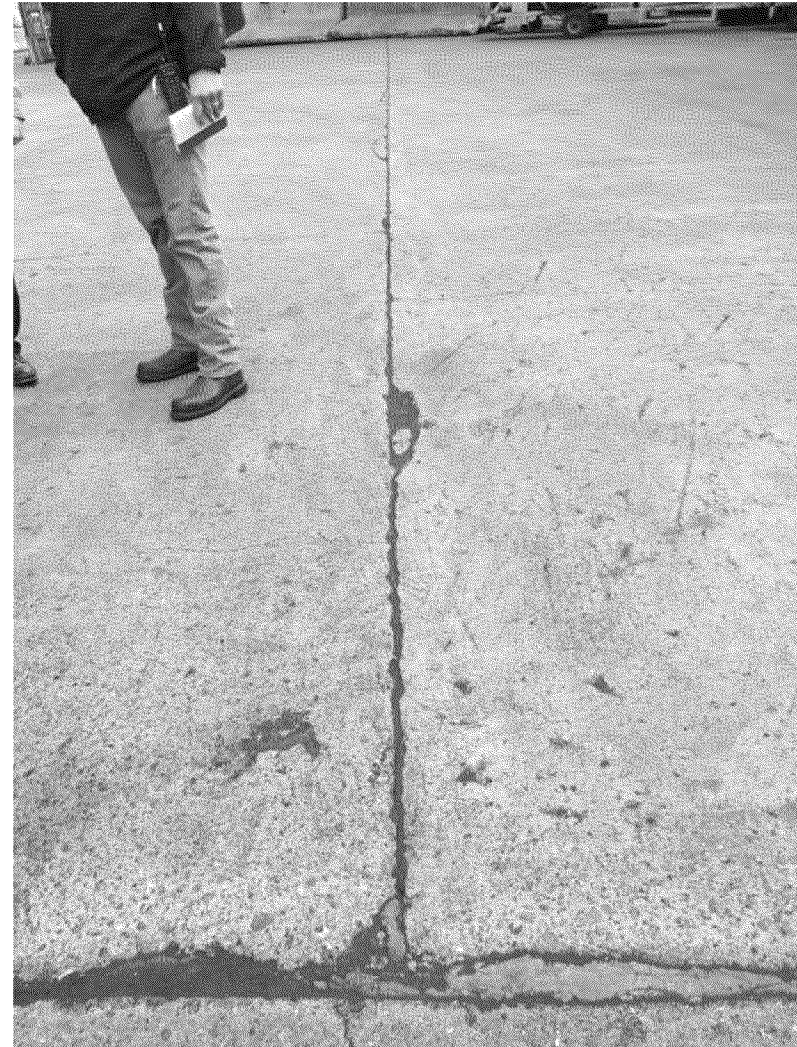
Photo 2 – Looking south along western alley of secondary storage area: sealed surficial cracks at concrete seam.

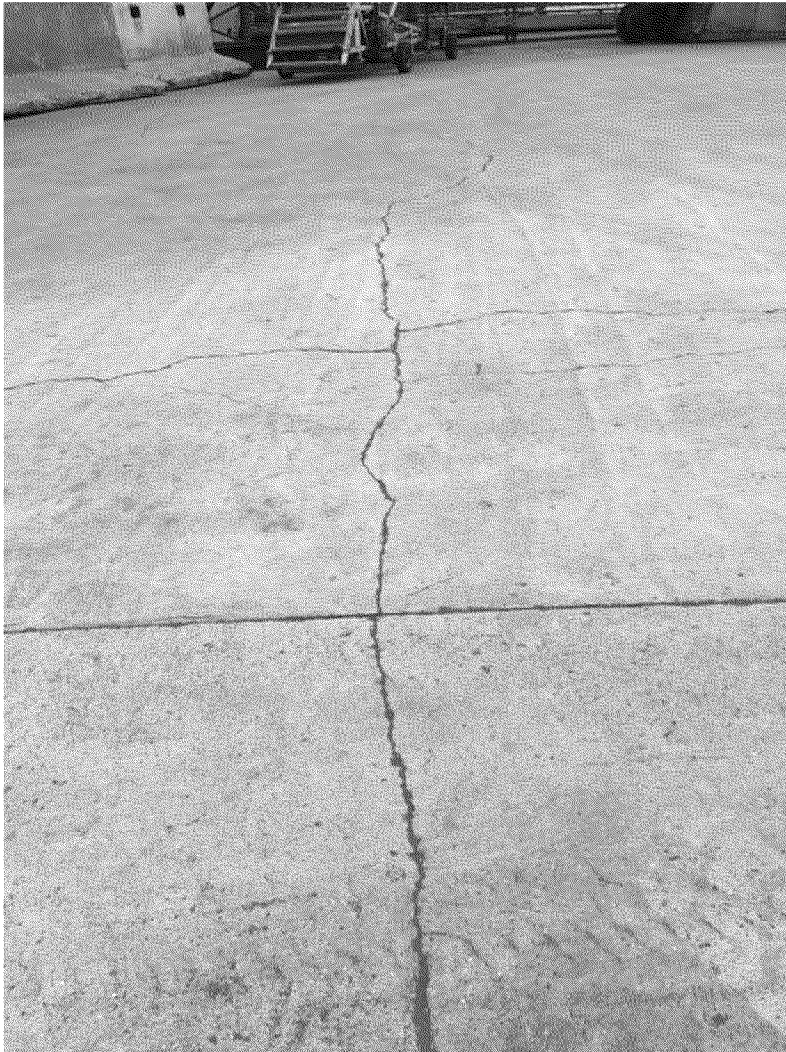
Photo 3 – Looking west across western alley of secondary storage area: surficial cracking in SW-3 area.

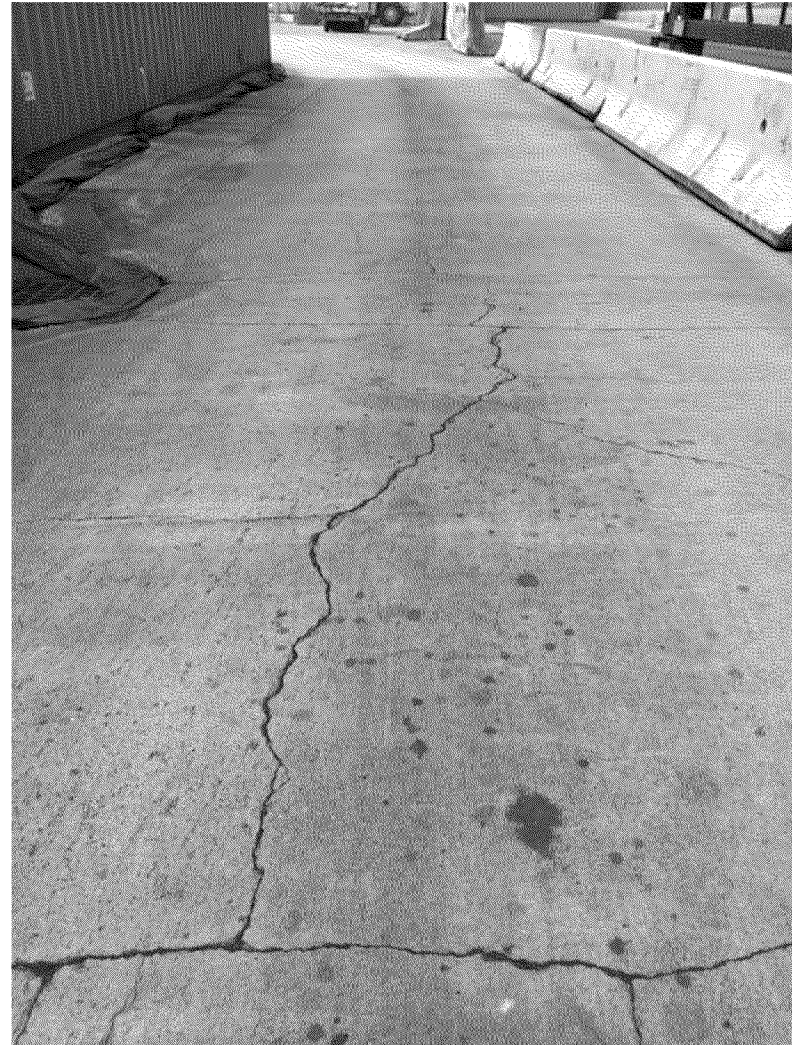
Photo 4 – Looking south along western alley of secondary storage area: surficial cracking near drain inlet 3DI-11.

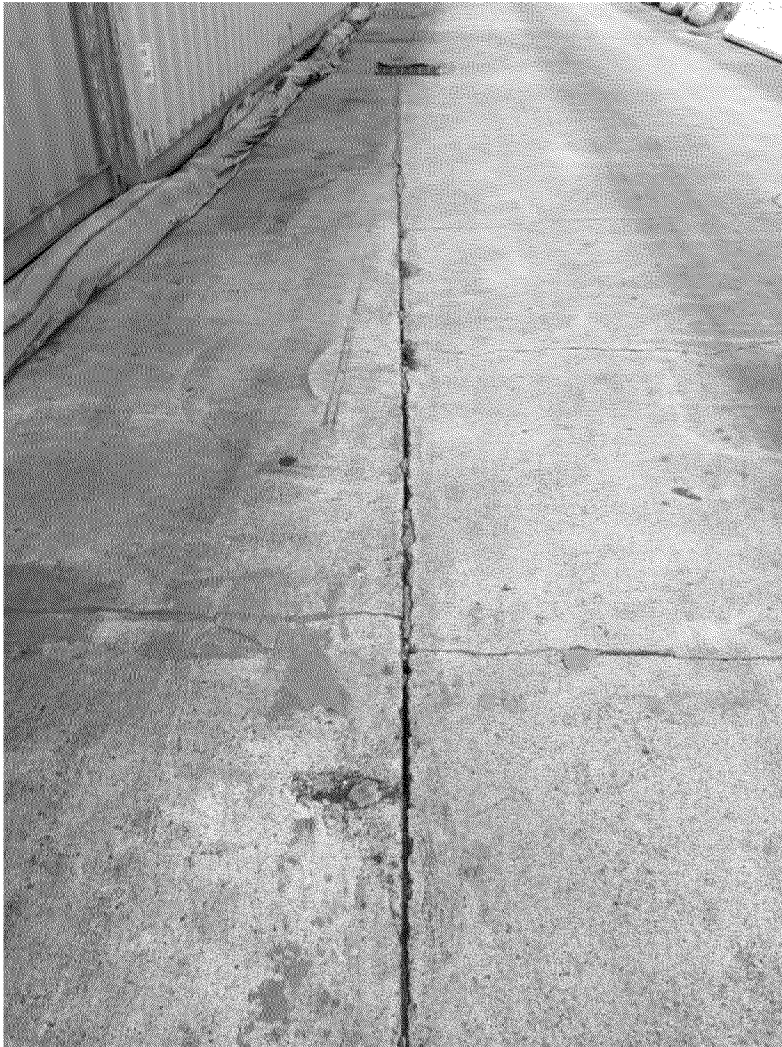
Photo 5 - Looking south toward drain inlet 3DI-11A: areas of surficial cracking and concrete seam.

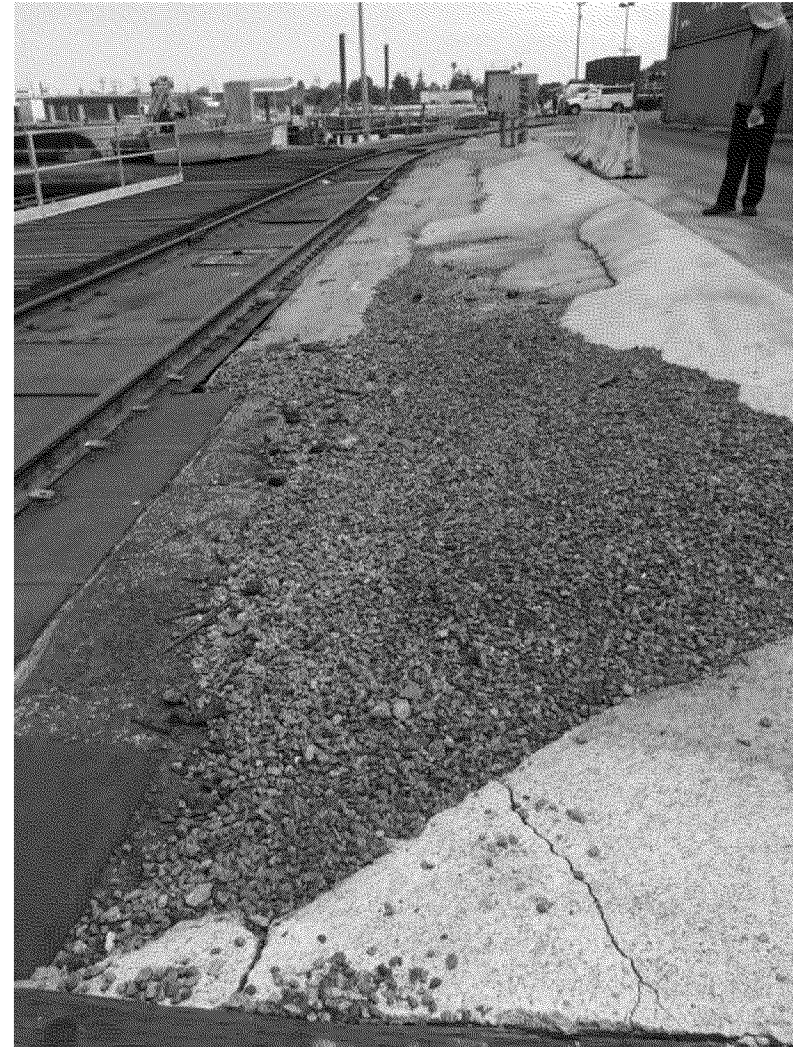
- **SW-4 Area** – Areas of minor surficial cracks were observed along the rail line south of interceptor SW-4 (Appendix A; Photo 6). Sealant was noted extending from the southeast corner of interceptor SW-4 toward the east (Appendix A; Photo 7). Minor surficial cracks were observed north of interceptor SW-4 (Appendix A; Photo 8).

- ☐ **SW-4 Area** – The gravel cover in this area was observed to be thin in one area; the underlying geotextile fabric was not exposed in this area (Appendix A; Photo 6).
- ☐ **SW-5 Area** – The gravel cover was observed to be thin in some areas, while the underlying geotextile fabric was not exposed (Appendix A; Photo 10).

Photo 6 – Looking north, surficial cracks and areas with sparse gravel coverage; area will be modified to have combination of gravel and concrete cap.

- ☐ Add gravel to gravel cover areas of SW-4 and SW-5;
- ☐ Monitor deteriorated concrete in the southern portion of the eastern swale of the Main Terminal at SW-6, and replace affected sections of concrete should further deterioration occur or evidence of underlying soil be observed;
- ☐ Implement BMPs identified in the LRT SWPPP (Weiss, 2015).

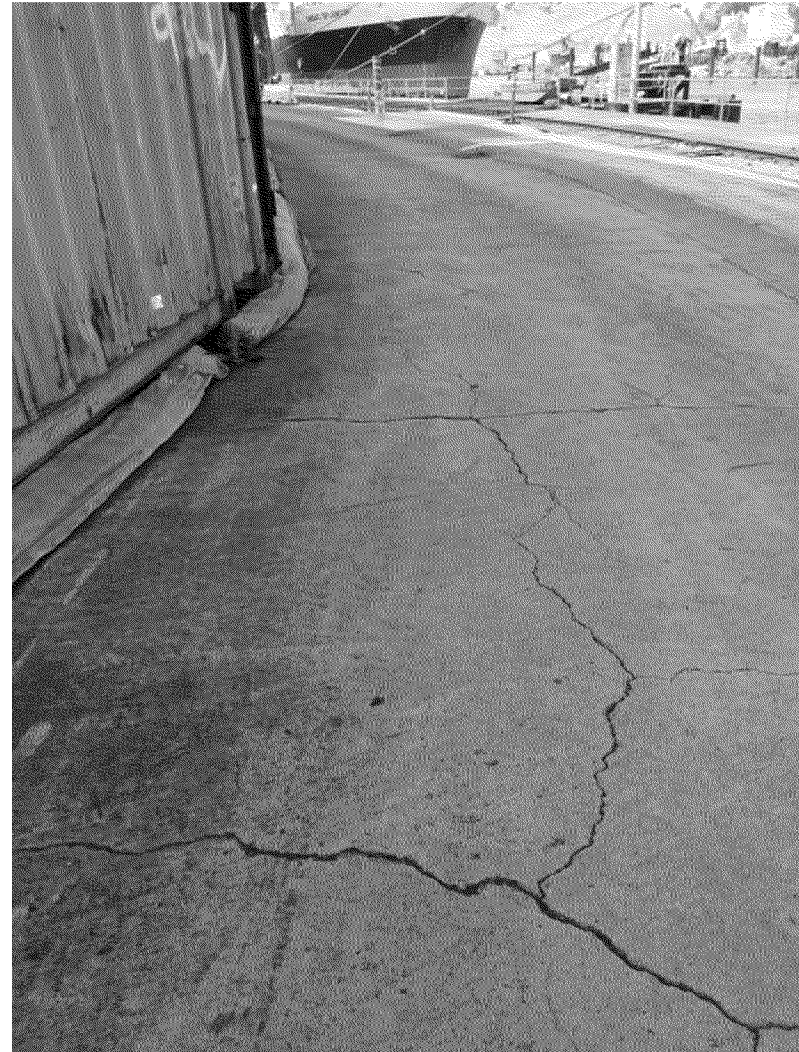
Photo 8 – Looking southwest toward 4DI-19: surficial cracks. sealant added in December 2013.

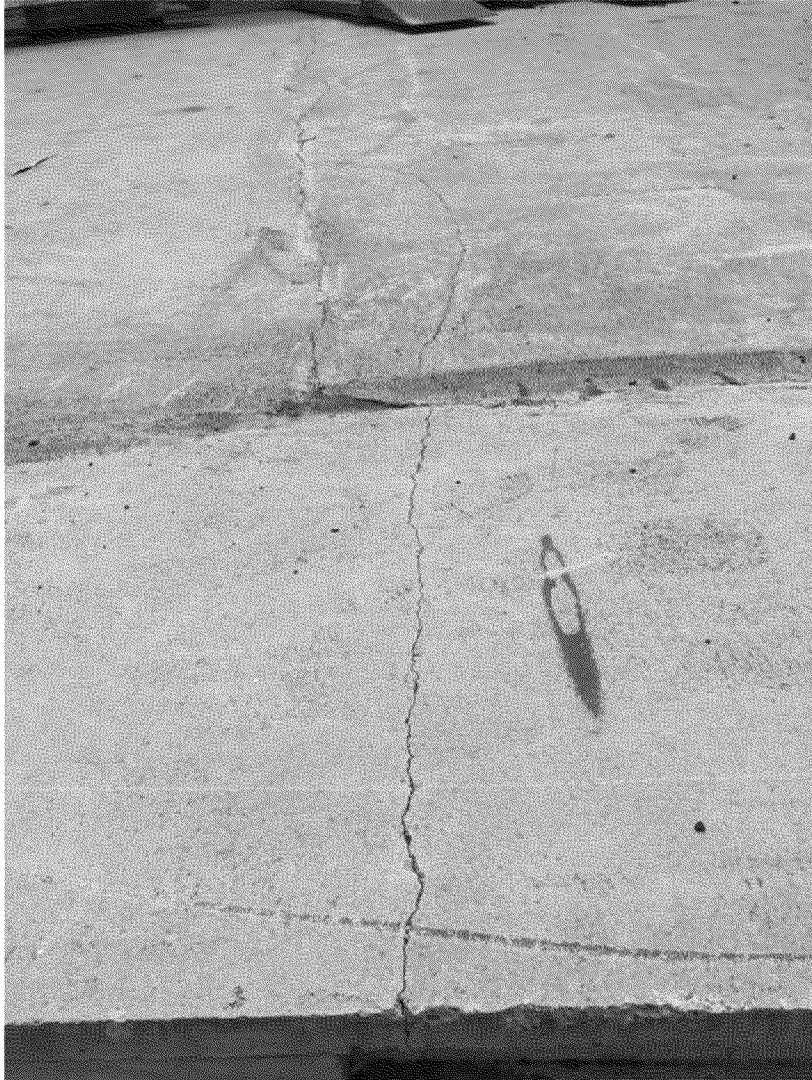
- **SW-5 Area** – Minor cracks were noted north and south of interceptor SW-5 (Appendix A; Photos 9 and 11). Light gravel cover was observed to the north of interceptor SW-5 (Appendix A; Photo 10).

Photo 9 - Looking east: surficial cracks.

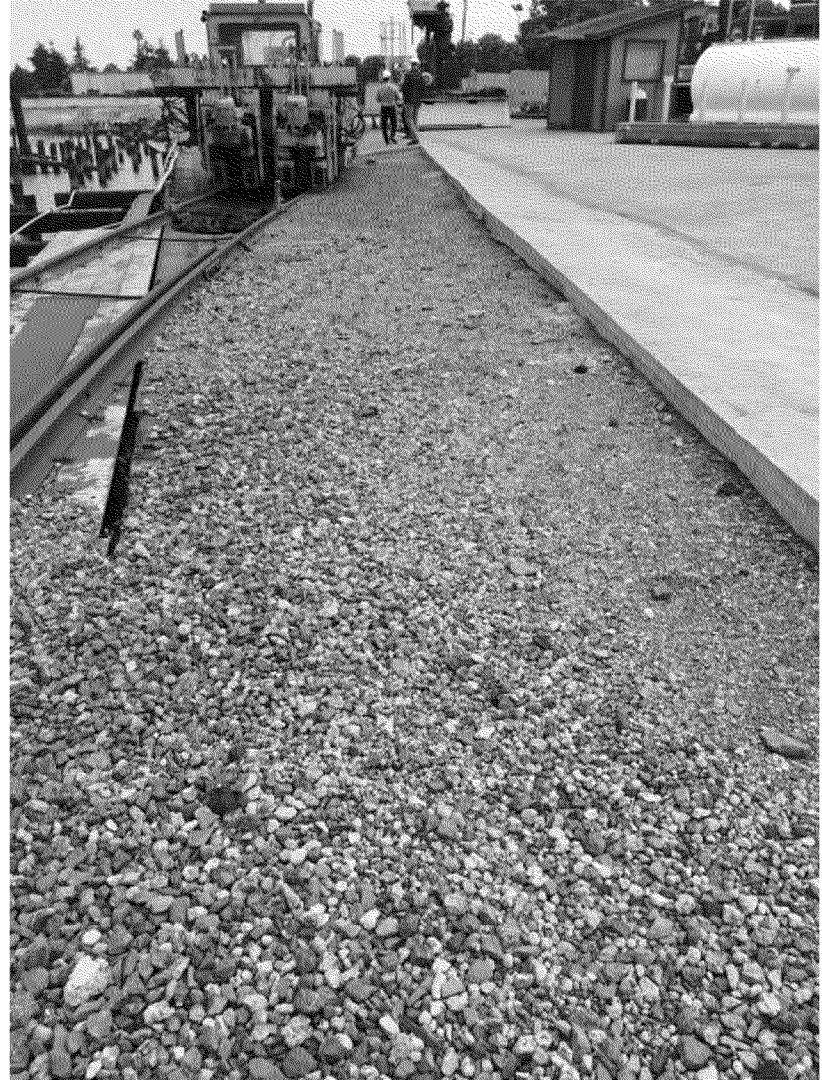
Photo 10 - Looking north: gravel cover.

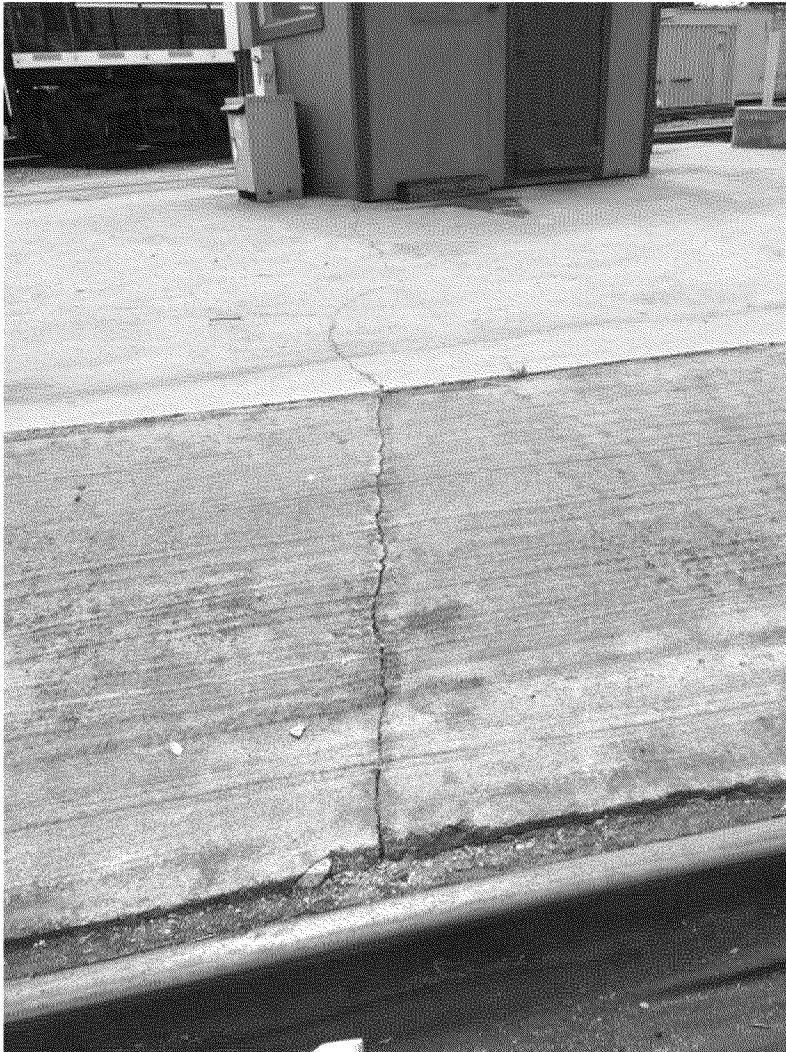
Photo 11 – Looking east: surficial cracks.

Aspect	Description	Anticipated Completion Date
General	Implement all activities (i.e., cap maintenance, storm water monitoring, interceptor cleanout) described in the O&M Plan. ¹	Continuously
	Submit report of O&M performed for the period of July 1, 2015 to June 30, 2016.	On/around July 15, 2016
Concrete Cap	Perform 2015-2016 annual inspection of the cap under oversight of a registered engineer.	June 1, 2016
	Monitor deteriorated concrete in the southern portion of the eastern swale of the Main Terminal identified in Photos 17 and 18 (Appendix A); replace affected sections should evidence of underlying soil be observed.	Continuously
	Monitor identified cracks, seals, and joints for signs of propagation and/or degradation throughout upland capping system.	Continuously
Gravel Cover	Add gravel to the interceptor SW-4 and SW-5 areas identified in Photos 7 and 11 (Appendix A) to ensure proper coverage.	October 1, 2015

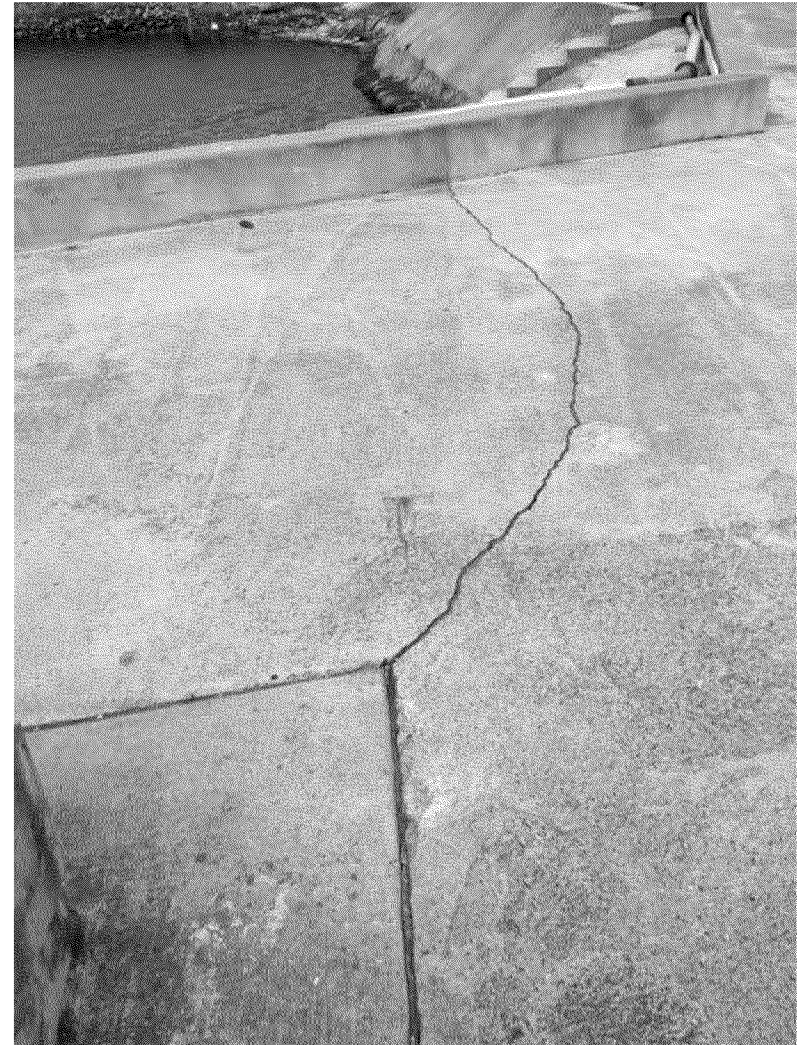
- **SW-6 Area** – Minor cracks were noted north and northeast of interceptor SW-6 (Appendix A; Photos 12 and 14). Seams and surficial cracks were observed in the eastern swale of the Main Terminal (Appendix A; Photos 15 and 16). Small areas of concrete deterioration were observed in the southern portion of the eastern swale of the Main Terminal (Appendix A; Photos 17 and 18).

Photo 12 – Looking west toward Municipal Outfall: seams and surficial cracks.

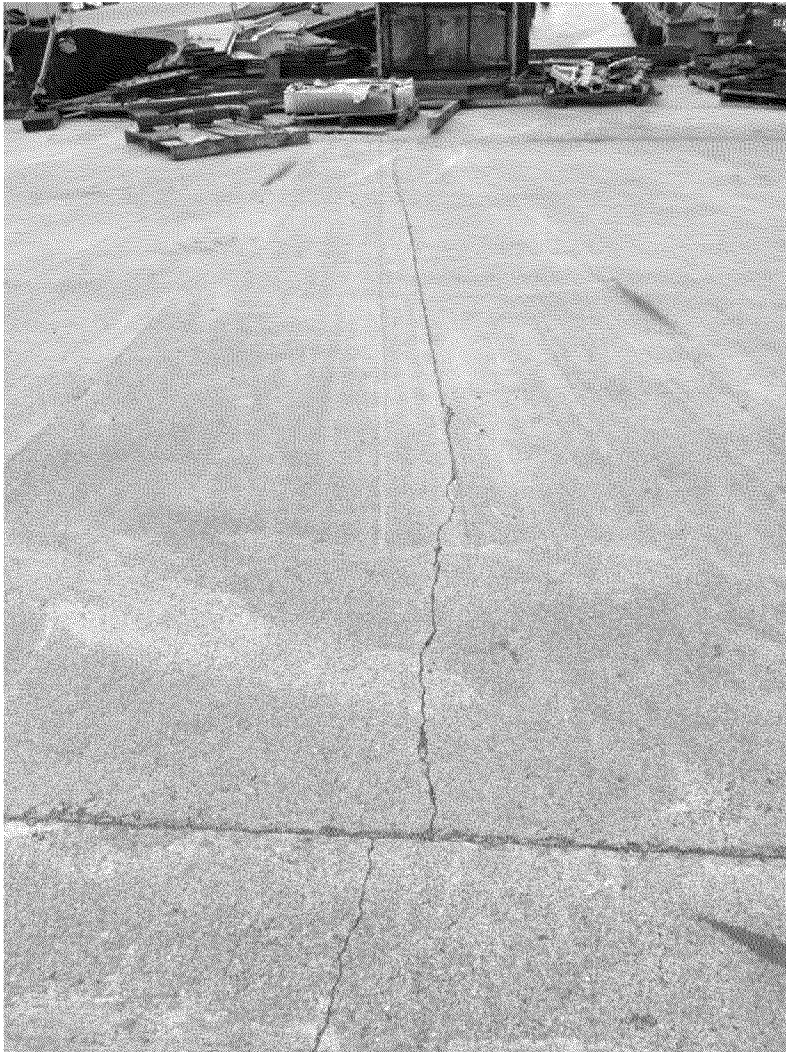
- **SW-7 Area** – Minor cracks were observed to the northeast of interceptor SW-7 (Appendix A; Photo 13).

Photo 13 - Northwest corner of site, looking south near interceptor SW-7; minor surface cracks noted.

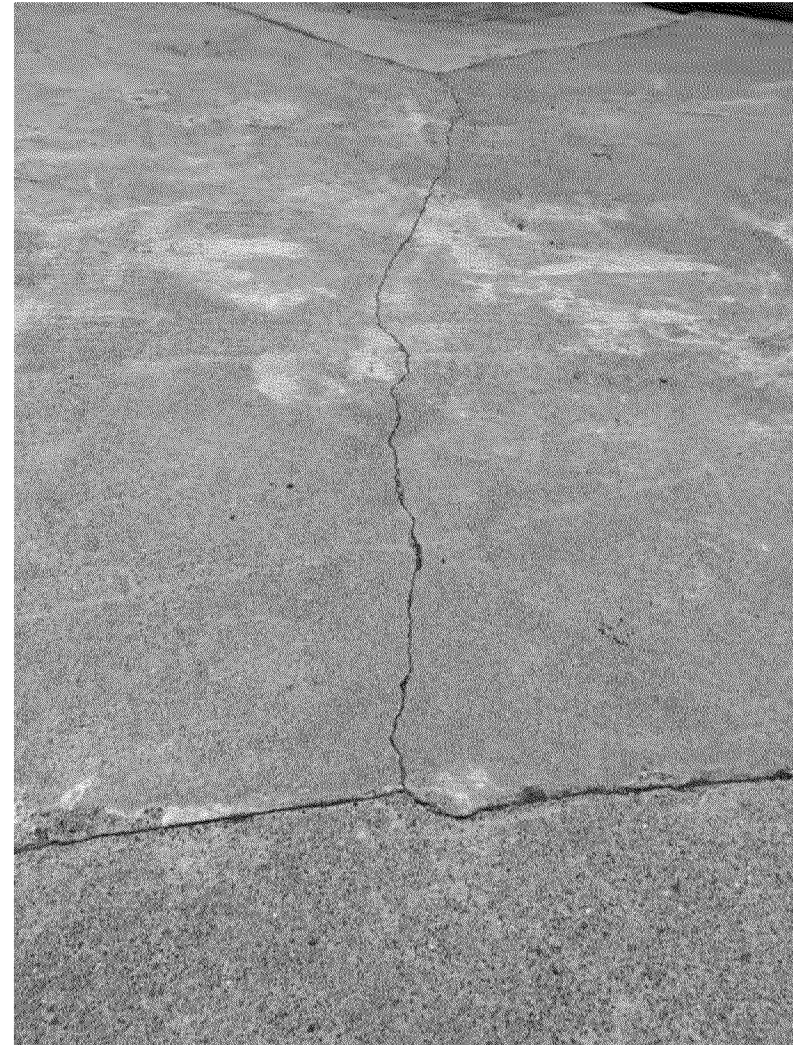
Photo 14 - Northeast corner of site; minor surface cracks.

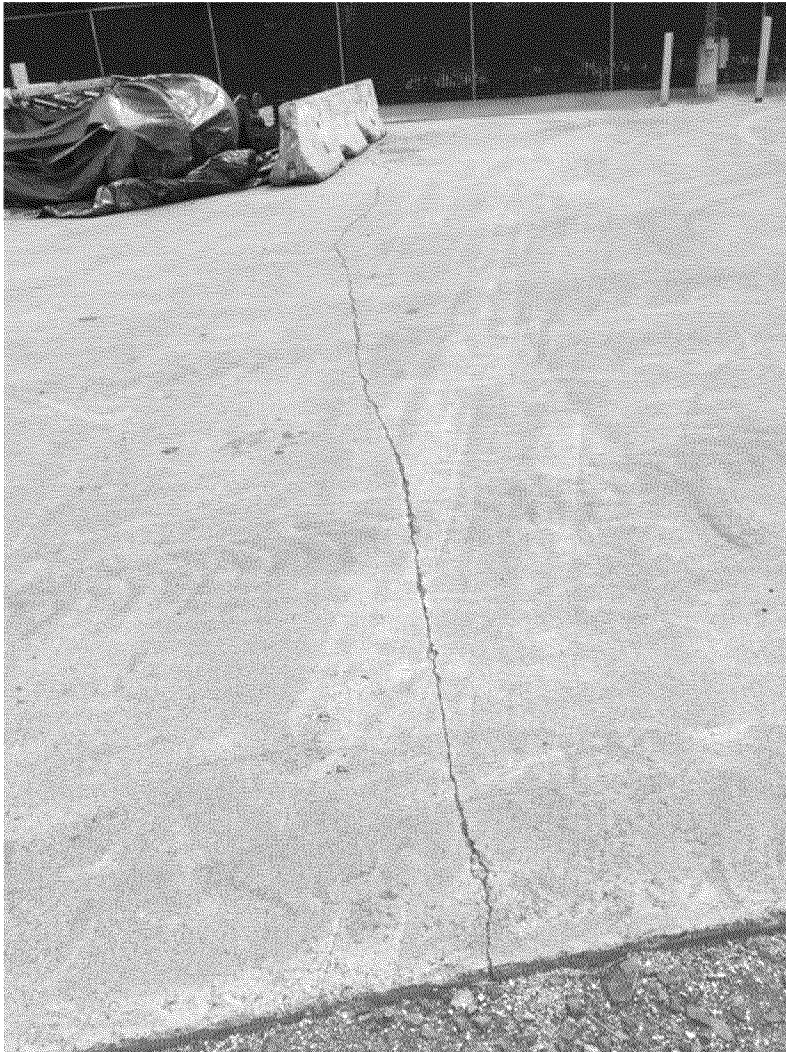
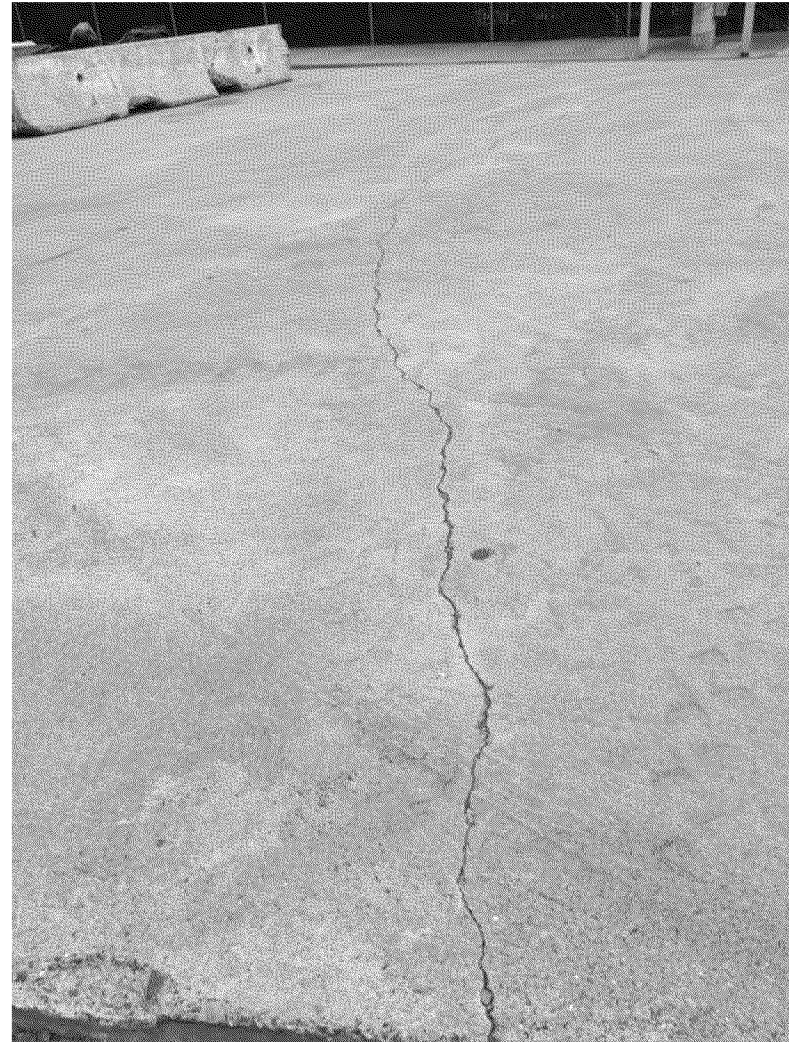
Photo 15- Area southeast of interceptor SW-6: minor surface cracks.

Photo 16 – Area southeast of interceptor SW-6: minor surface cracks.

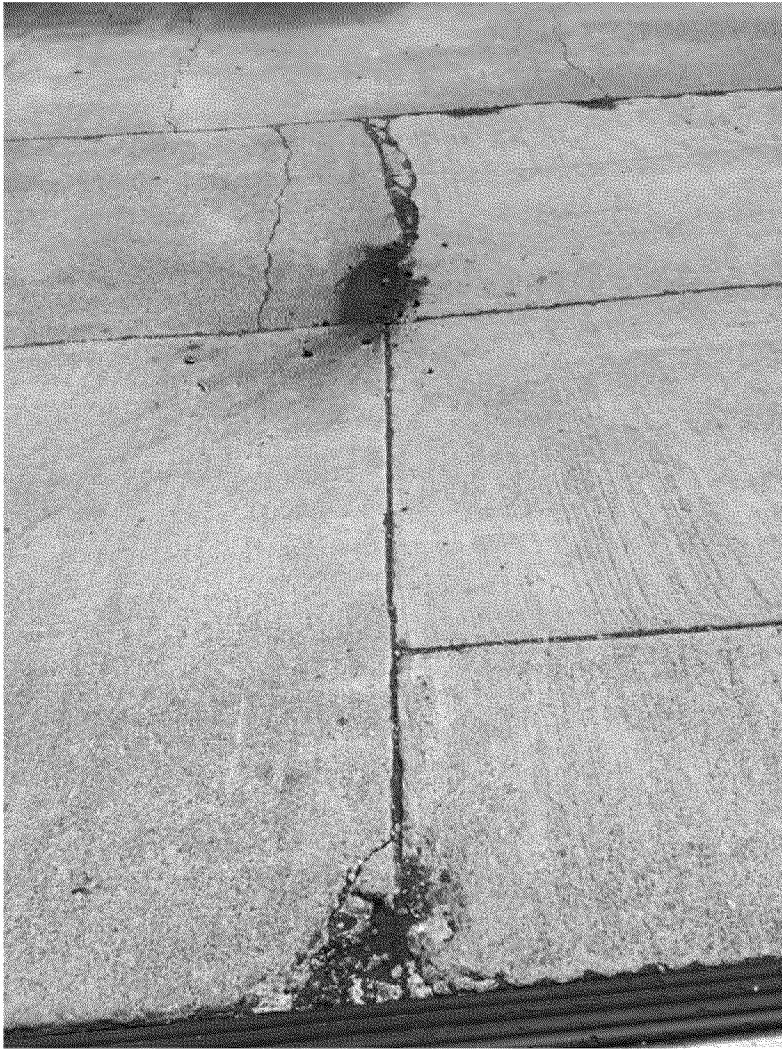
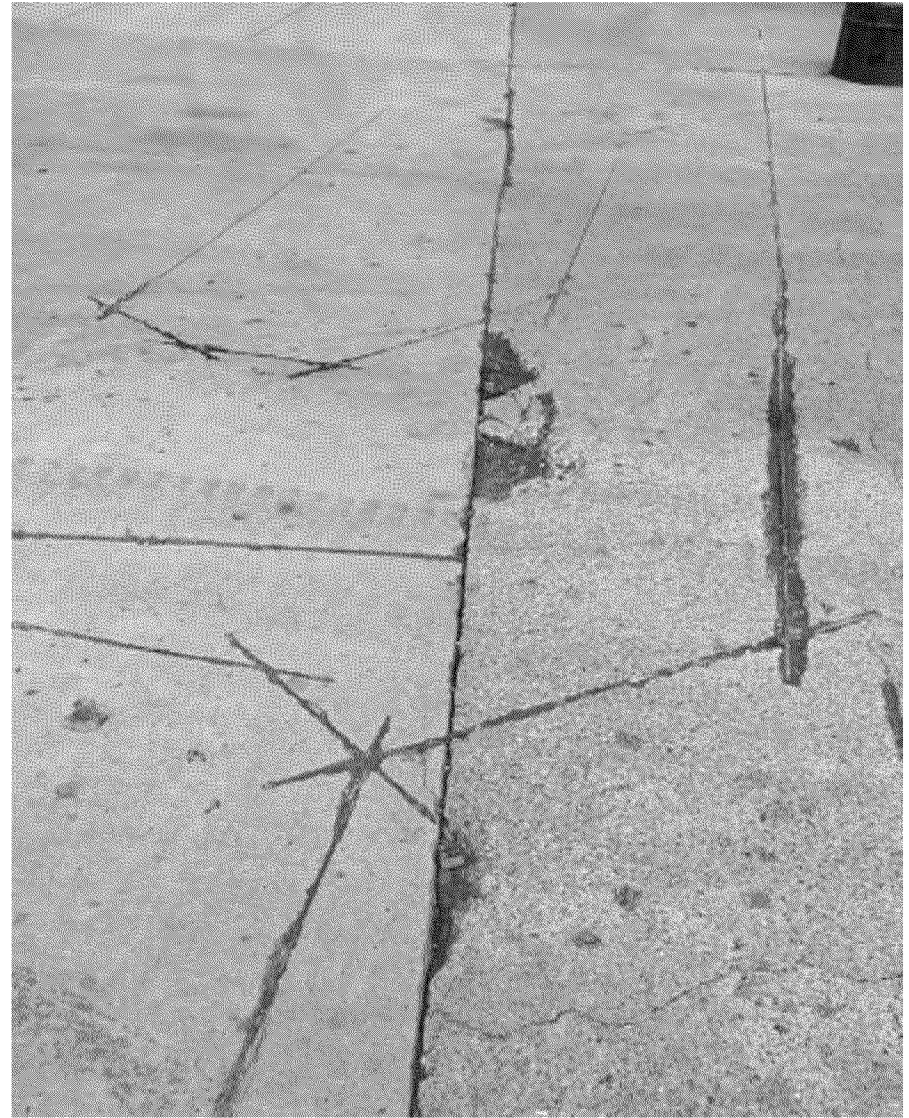
Photo 17 – Looking east, north of 5DI-14A: areas of minor concrete deterioration.

Photo 18 – Looking east, north of 5DI-14A: areas of minor concrete deterioration.
